NATIONAL BUREAU OF STANDARDS REPORT

ANNUAL REPORT FOR THE PERIOD ENDING DECEMBER 31, 1966 ON

INVESTIGATION OF THE DIRECTIONAL EFFECTS
IN THE STRESS CORROSION OF ALUMINUM ALLOYS

National Aeronautics and Space Administration
George C. Marshall Space Flight Center
Huntsville, Alabama

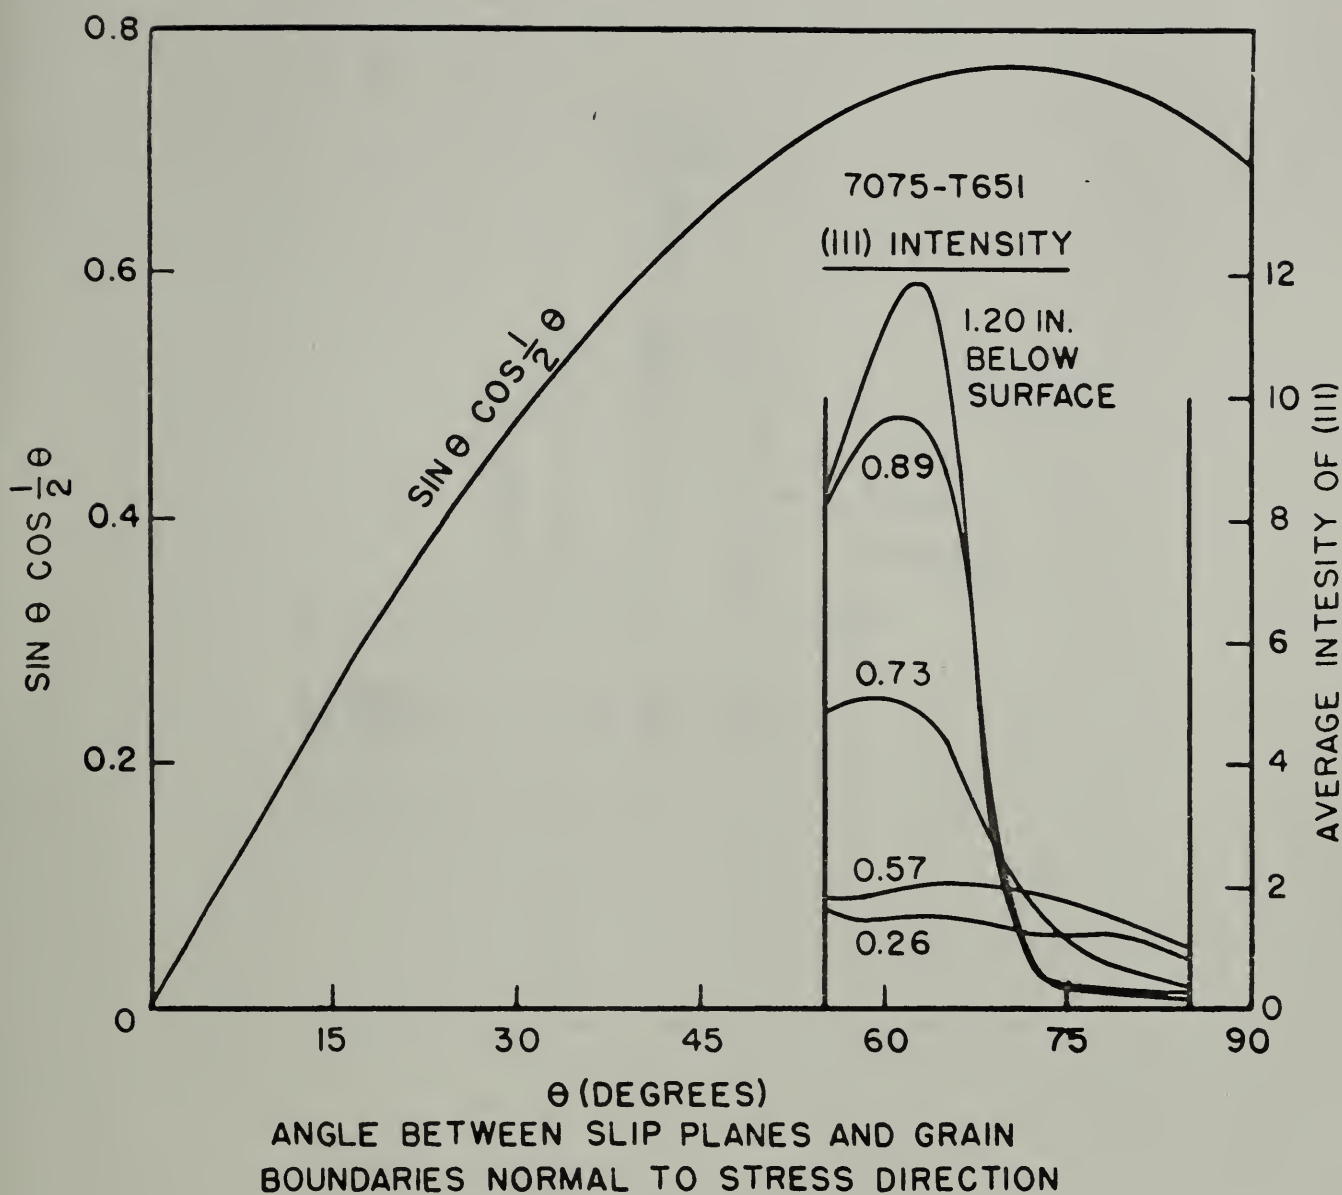
The probability of cracking is shown plotted against the angle between slip planes and grain boundaries normal to the applied stress. Superimposed on this are plots showing the intensity of (111) reflections at various depths in a 7075-T651 aluminum alloy plate. The intensity of (111) reflections in the range from $\theta = 55^\circ$ to 85° is a measure of the number of (111) favorably oriented for stress corrosion cracking.

Figure 9 is a plot of $\sin \theta \cos 1/2 \theta$ against θ (the angle between slip planes and the grain boundaries). It is seen that the probability of cracking is greatest at 70° . Also shown on this graph are plots of average intensities of (111) vs. θ for the specimens taken from various levels within the plate. Average intensities for five degree angle ranges were taken from the X-ray data because of the highly fluctuating nature of that data. Figure 9 clearly indicates that stress corrosion susceptibility should increase with distance from the surface of the plate.

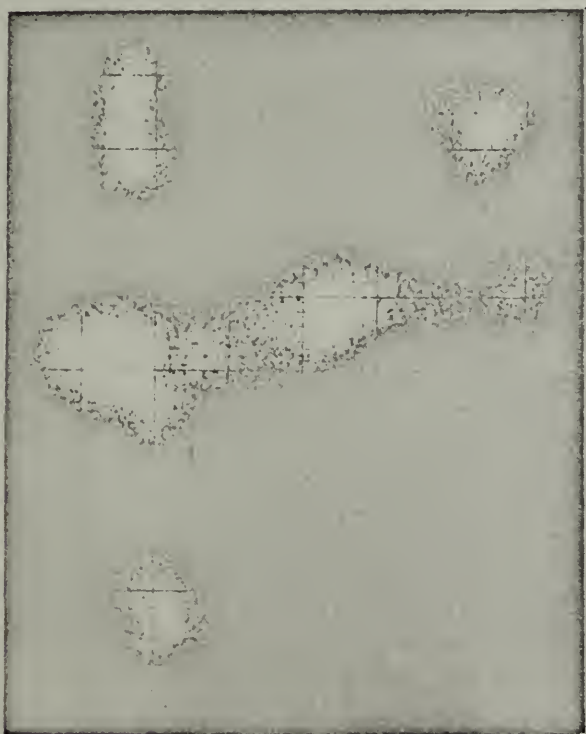
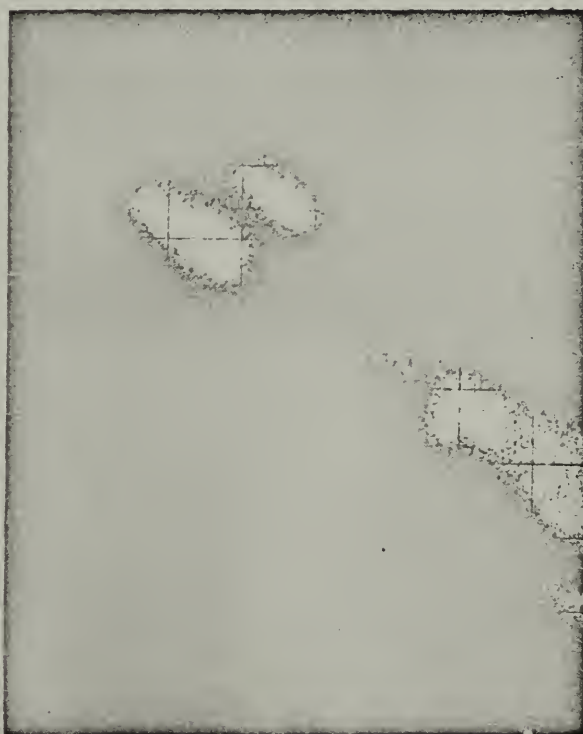
Figure 16. Iron X-ray images of areas shown in

Figure 14. Light areas are high in iron.

Figure 16, the iron X-ray images, shows iron to be highly segregated at the dark particles of Figure 14. Copper and manganese were also segregated at these inclusions. Aluminum and zinc were found to be depleted at all inclusions.
